SUBJECT: "Investigation of Design, Construction, and
Erosion Control Methods for Use in Wind-
blown Silts;" KYHPR-64-14, HPR-1(1), Part II.

HIGHWAY CONSTRUCTION IN WINDBLOWN
SILTS OF WESTERN KENTUCKY

January, 1967

US 41 By-Pass, Henderson, Kentucky

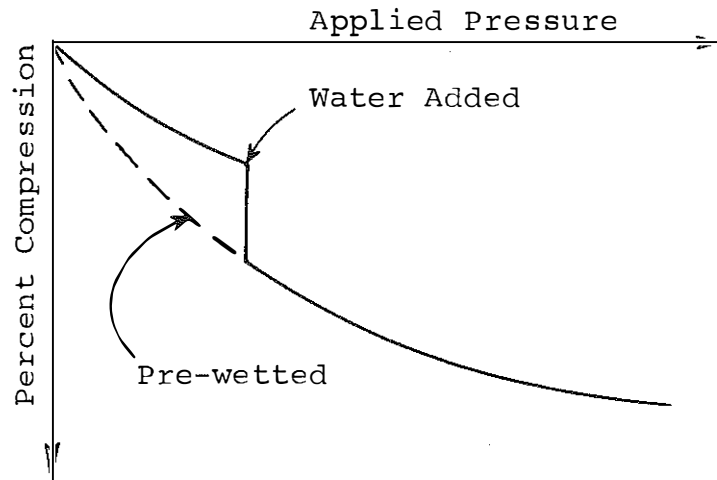
Figure 1. Typical Compression Curve of Water-Sensitive Loess.

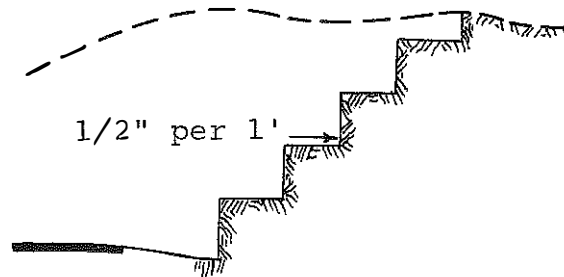
Figure 2. Typical Step Construction with Vertical Walls for Deep Cuts in Loess.

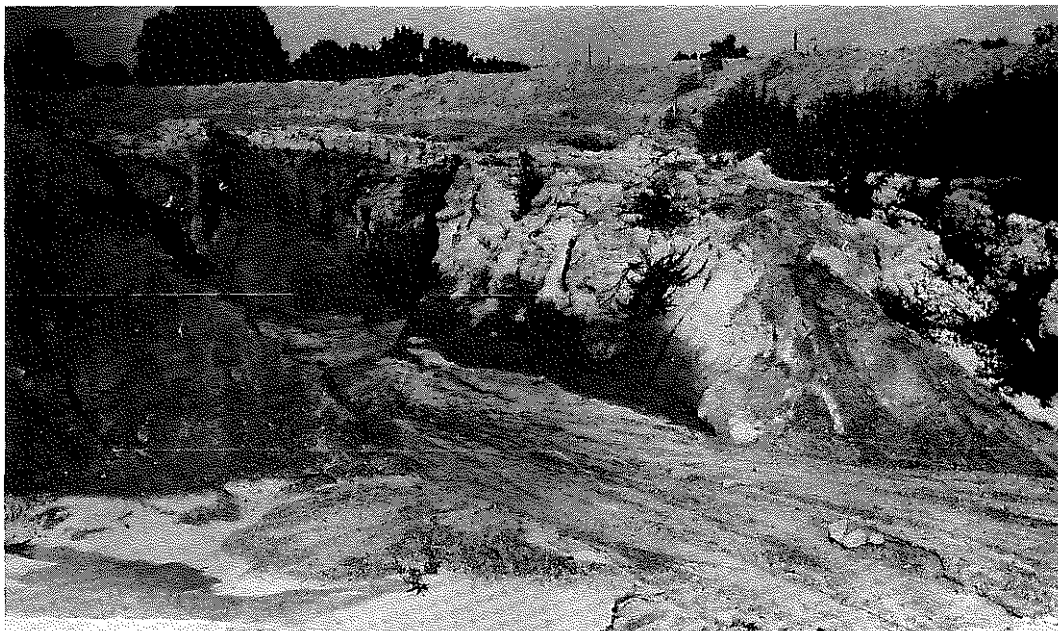
Figure 4a. Photograph Taken During the Construction of US 41 By-Pass (Henderson) Showing the Severe Susceptibility of Silt to Erosion. Note the near vertical walls and long, flat gradient of the gully (1962).

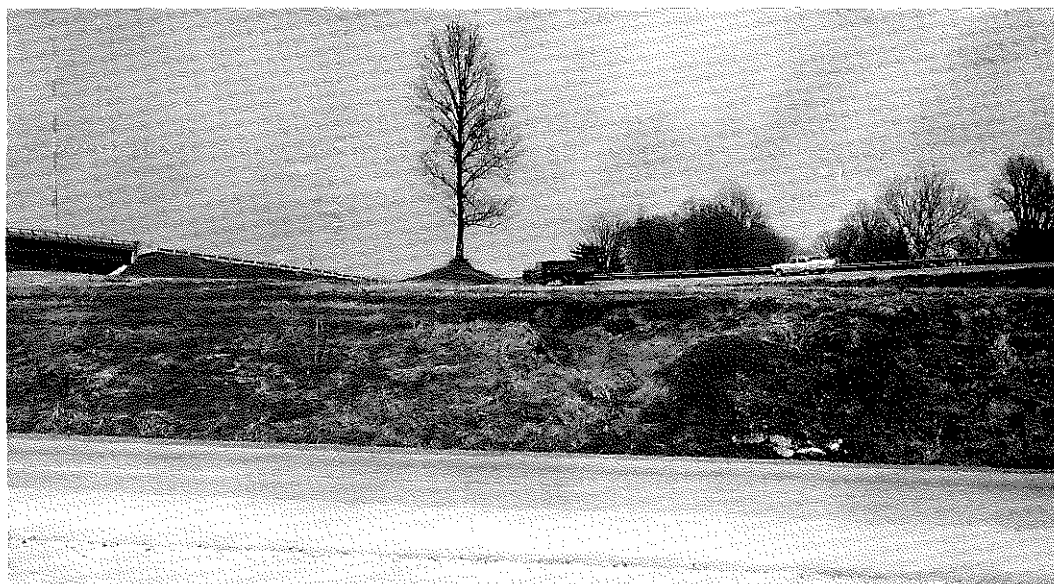
Figure 4b. Photograph of the Same Area Shown in Figure 4a Taken After the Completion of Construction. Note the tendency for the gully to take on the same shape as shown in Figure 4a and to develop in almost the same location (1964).

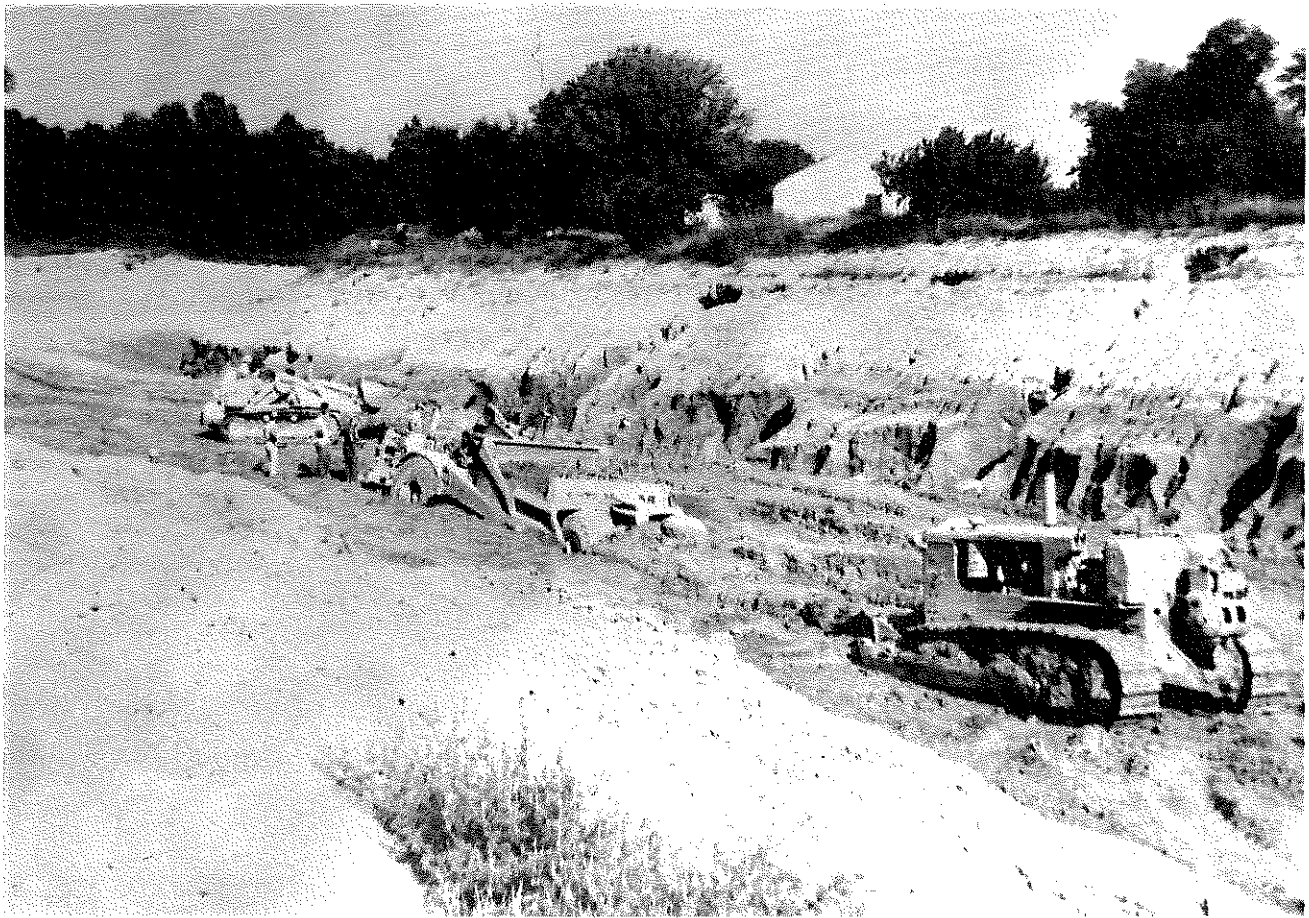
Figure 5. Photograph Taken on the Construction Project of US 41 By-Pass at Henderson Showing the Results Which Can Be Expected When Excess Pore Pressures Develop. Excess pore pressures are induced in the silt material under the load of construction equipment (1962).

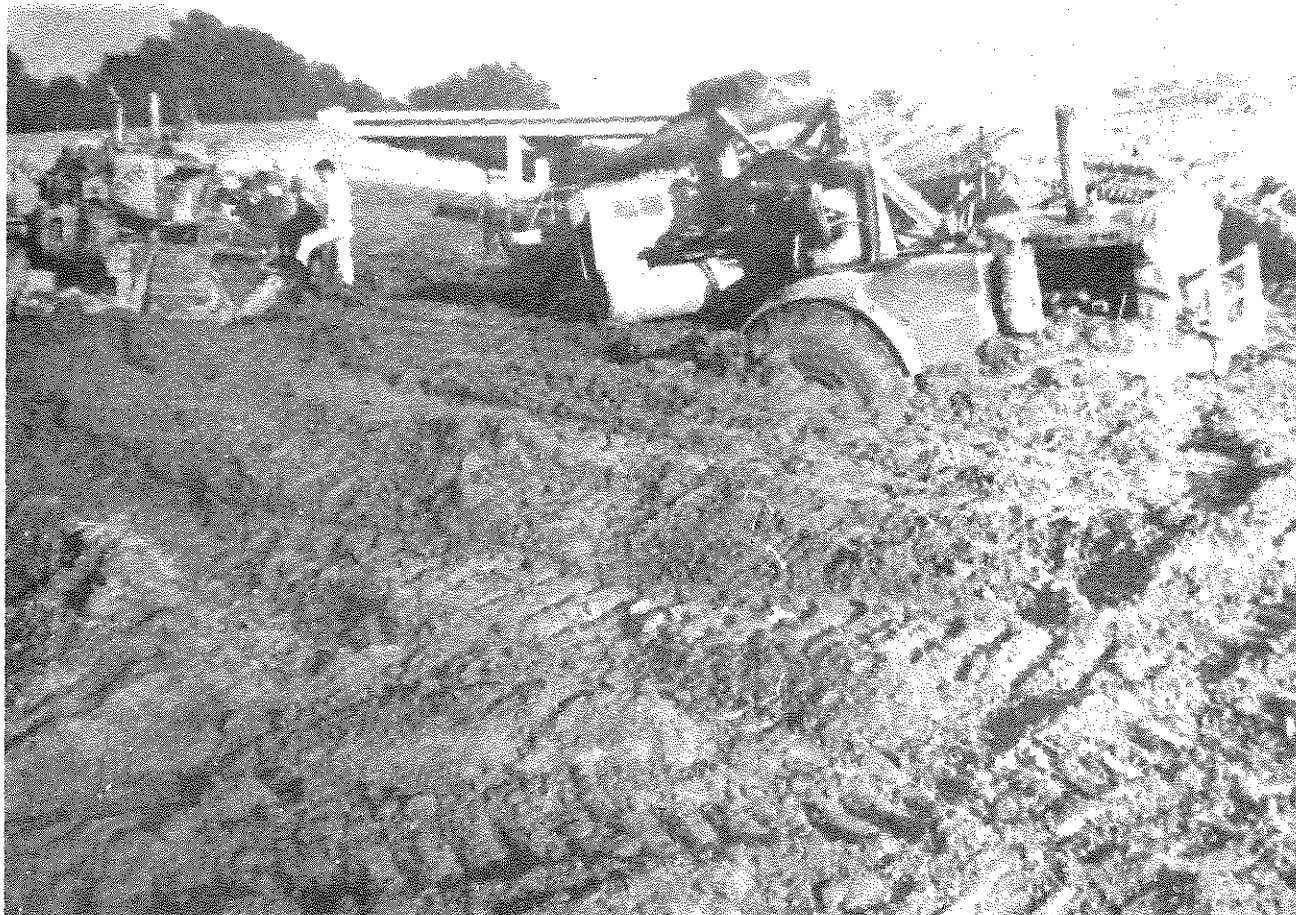
Figure 7. Photograph Showing the Results of the Extreme Sensitivity of Silt Materials to Moisture Content. The moisture contents remain at relatively high values as a result of high perched water tables and because of a capillary retention of water by silt materials. When such a material is loaded by construction equipment, for example, the soil becomes quick, loses a large portion of its load carrying capabilities, and thus is completely unable to support even the weight of the construction equipment.

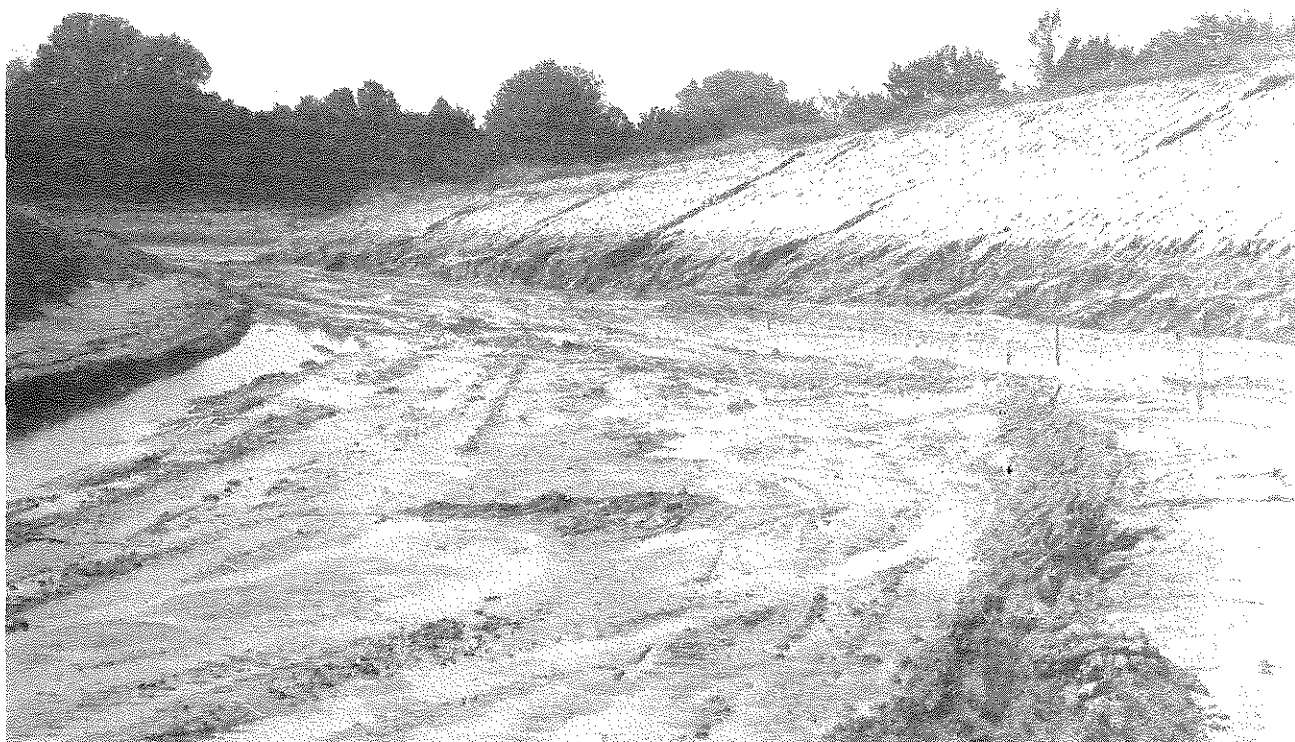
Figure 8. View of Cut Through a Loessal Hill on the Northern End of the US 41 By-Pass Project. A ditch approximately eight to ten feet deep had been excavated at the toe of the embankment shown on the right and had been maintained open throughout a complete winter season and well up into the summer season. Note the extremely wet condition of the roadway area and the high water table shown in the cut slopes by a change in color of the soil material. This high water table and wet condition was observed even after a deep ditch had been opened for several months to permit drainage. This suggests the high capillary retention of water in silt soils and the fact that horizontal drainage is very negligible. Note in the foreground in the roadway area numerous silt boils.

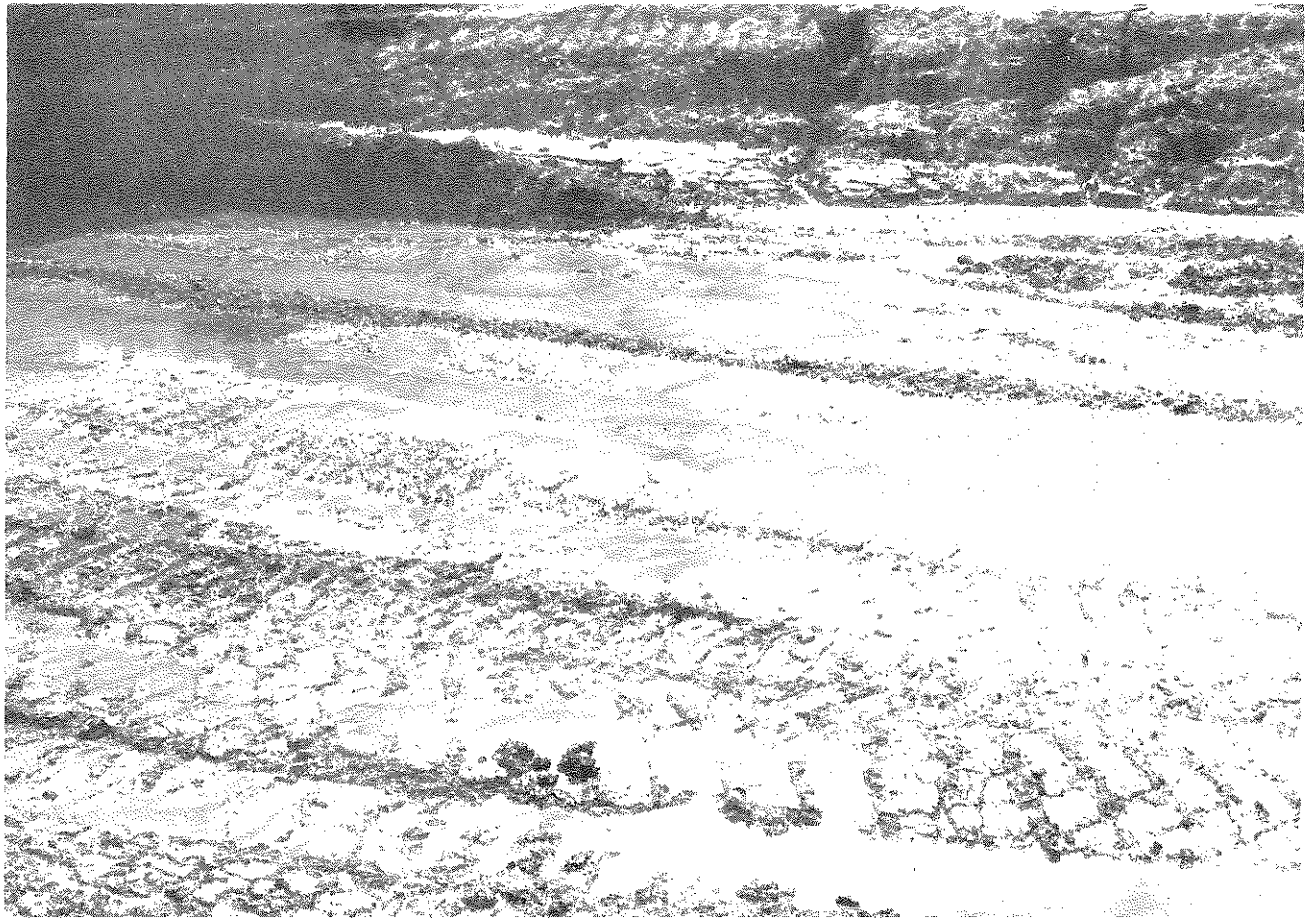
Figure 9. Close-up View of a Number of Silt Boils which Result When the Extremely Wet Silt Material is Loaded by Construction Equipment and the Induced Excess Pore Pressures Cause a Flow of Water in the Direction Offering the Least Resistance. In this particular situation near Henderson, the direction offering the least resistance to flow of the water was in a vertically upward direction; therefore, as the water reached the surface small boils (similar to volcanos) were formed over the surface of the material.

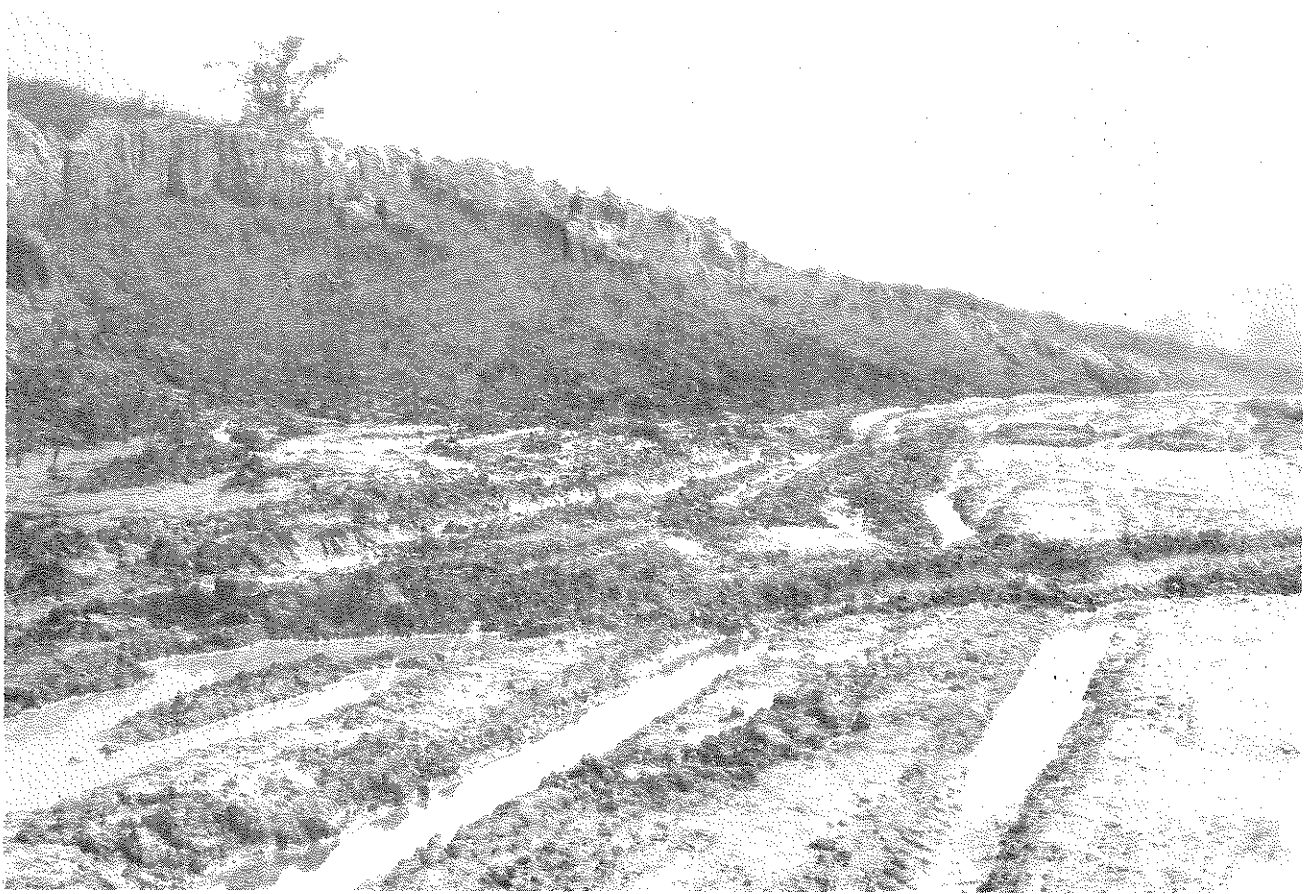
Figure 10. Photograph Showing the Extremely Wet Conditions of an Excavation even After Long Periods of Dry Weather. Note the tendency of the slope to slough on near-vertical walls.

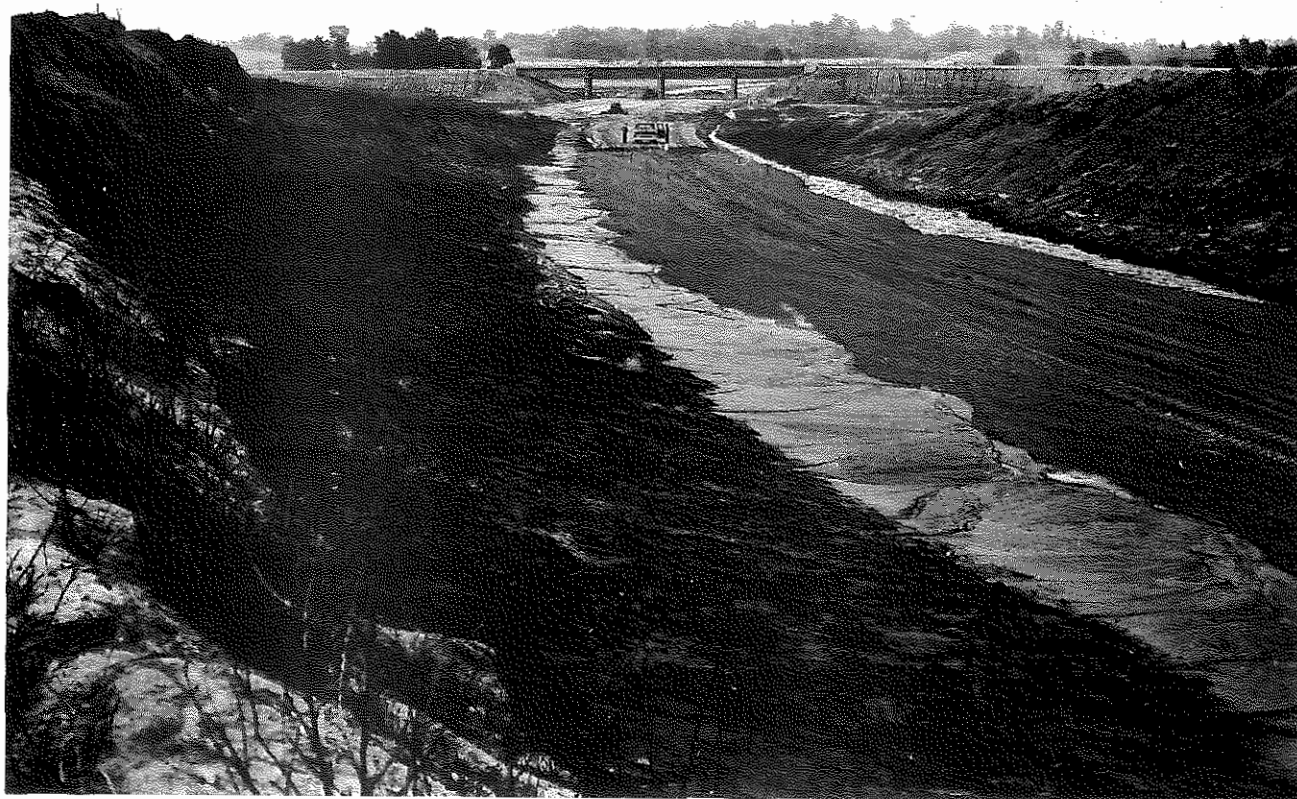
Figure 11. View of Troublesome Cut Area Showing Severe Susceptibility of Silt to Erosion. The material seen in the roadway is a sand blanket placed in an attempt to provide a drainage blanket and a working platform.

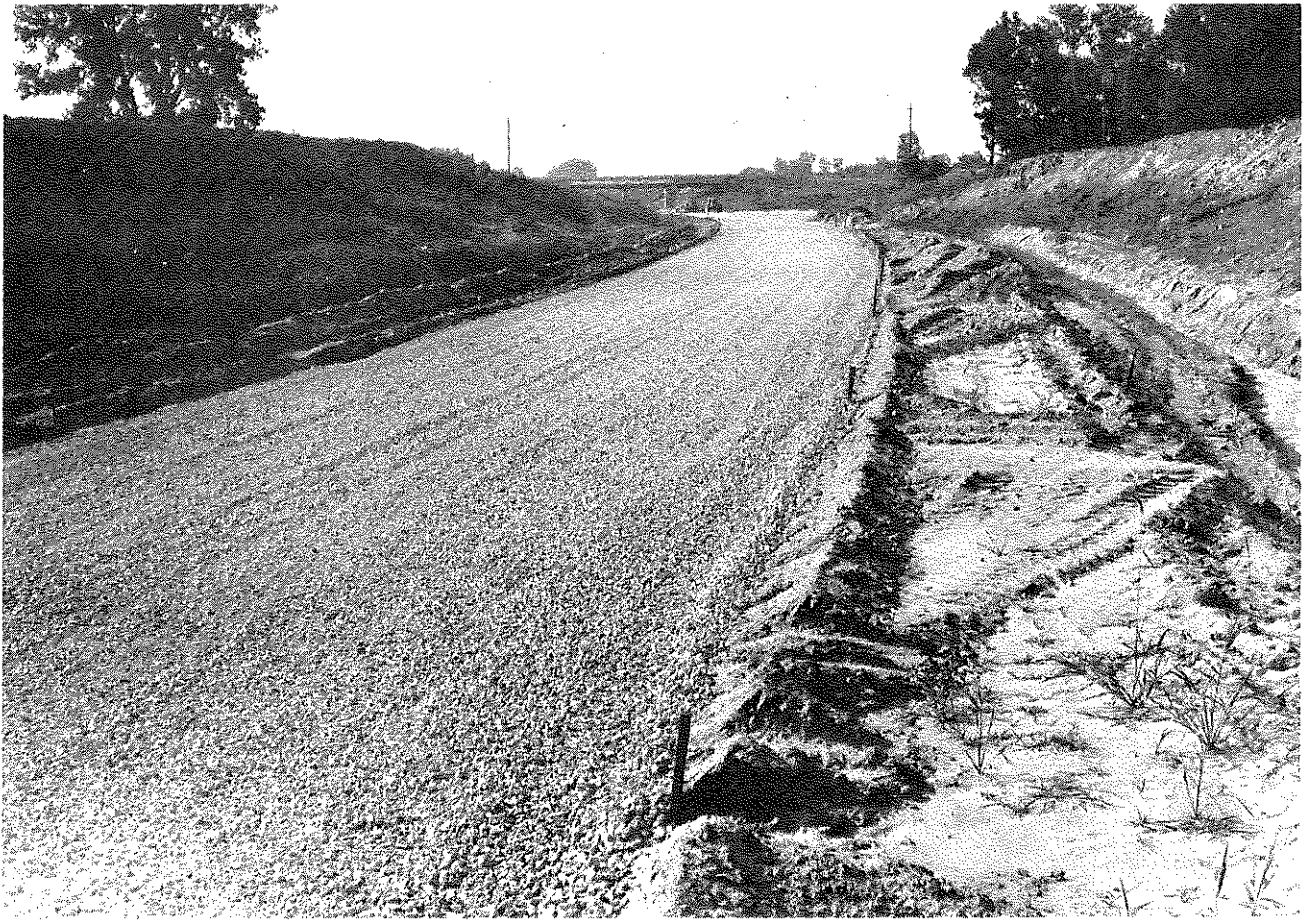
Figure 12. View of Troublesome Cut Area Showing the DGA Base in Place.

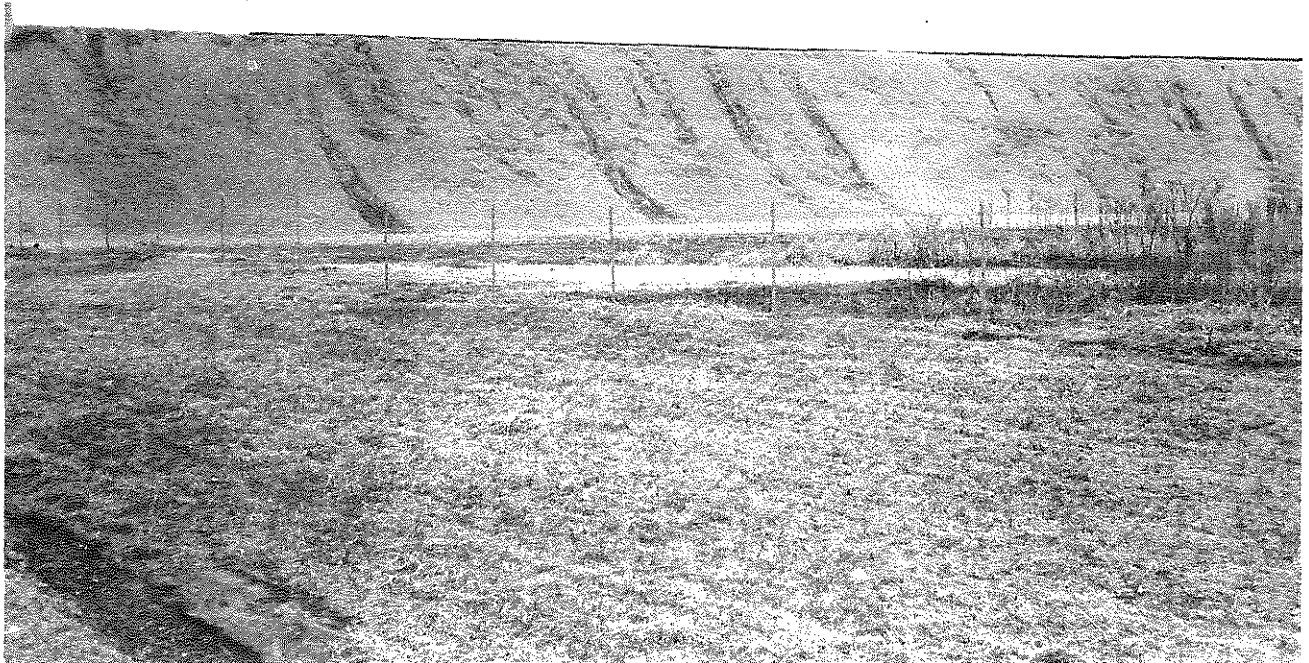
Figure 13. View of Completed Embankment Showing the Extreme Erosion Susceptibility of Silt in Compacted Embankments.

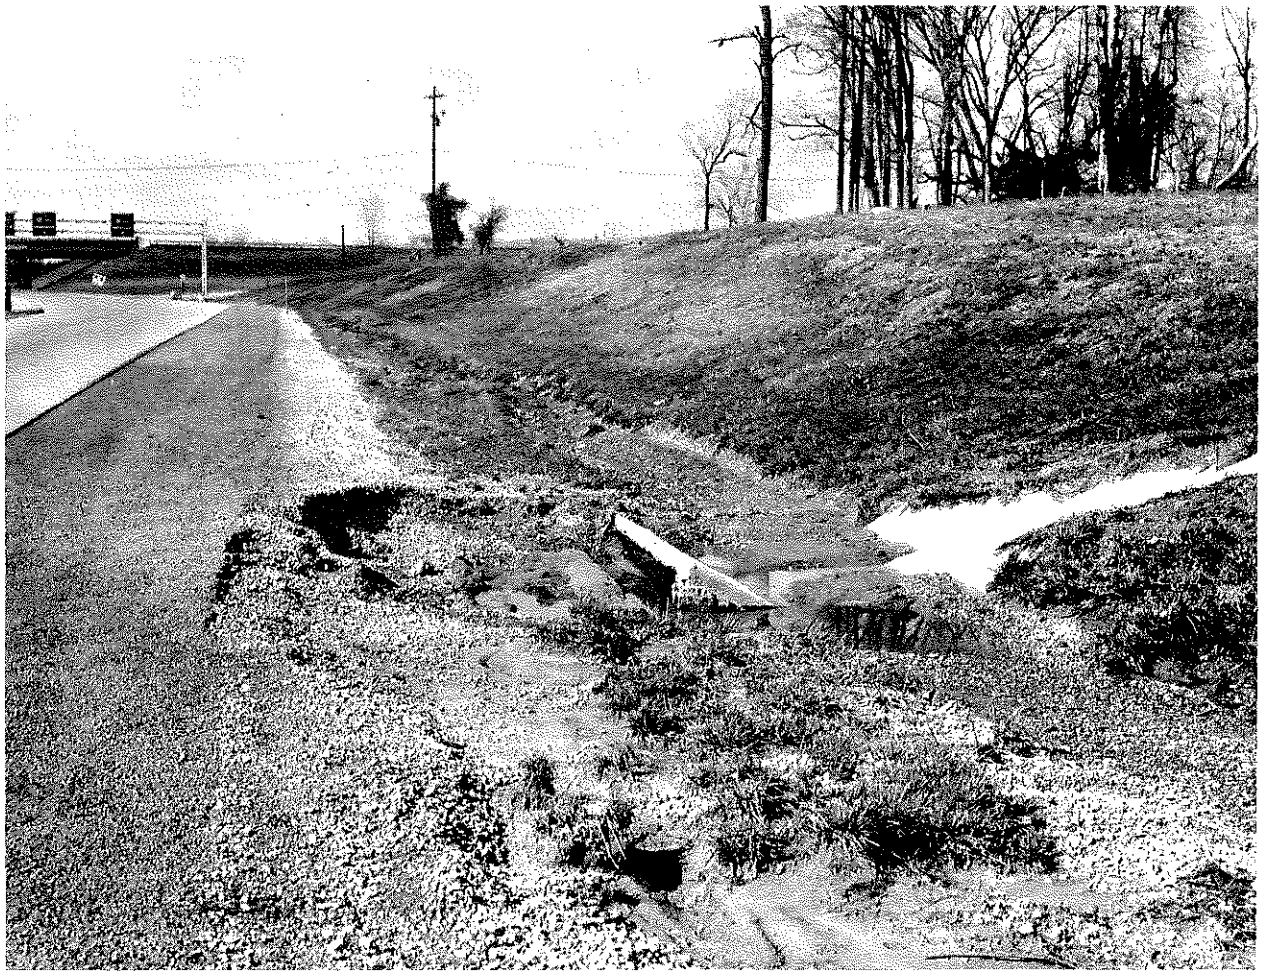
Figure 14. Photograph Taken Soon after the Opening of the By-Pass to Traffic Showing the Extreme Erosion Which Occurs in a Relatively Short Time Around Drainage Structures.

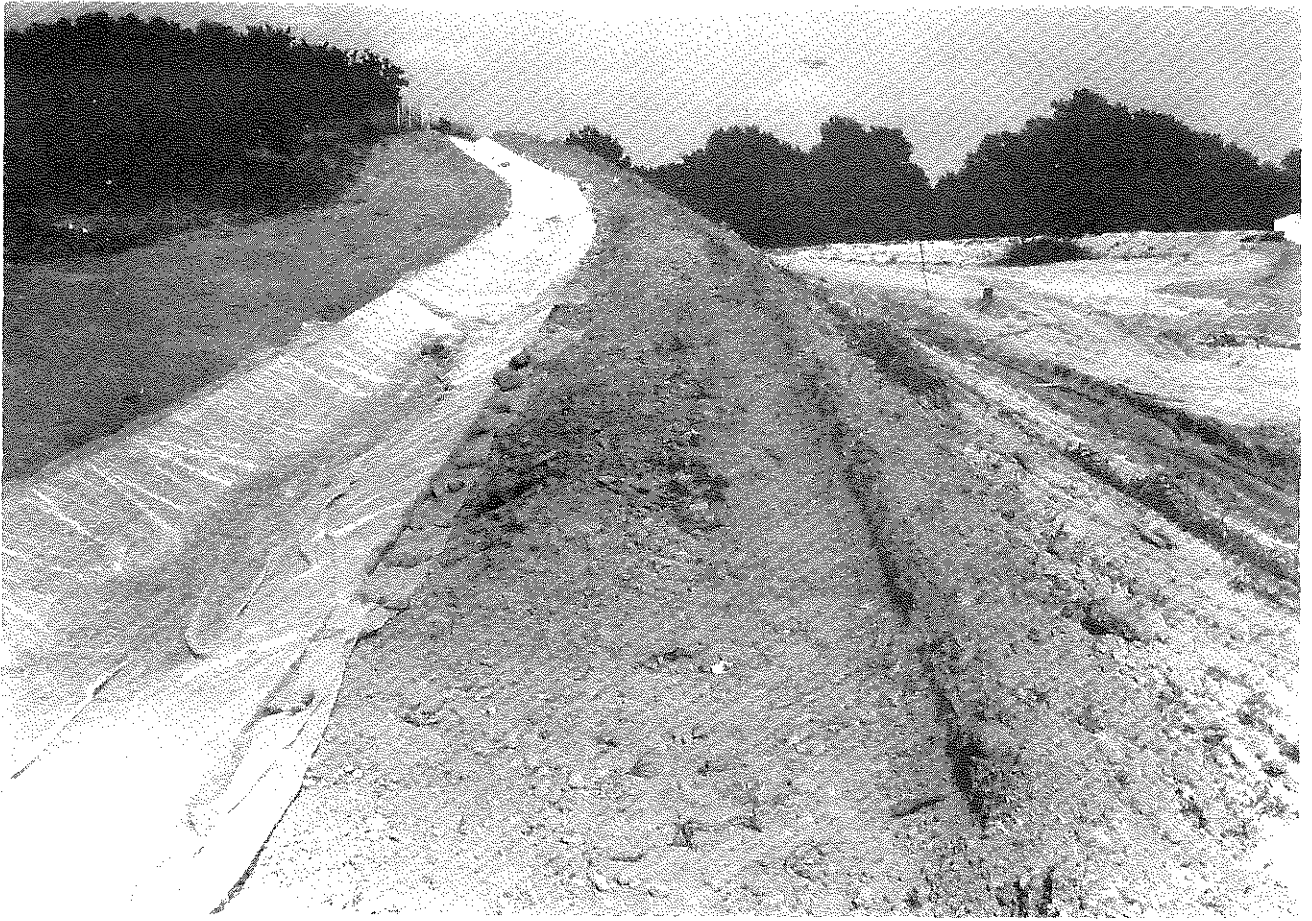
Figure 15. Photograph Showing the Construction of a Paved Ditch at the Top of a Cut Slope.

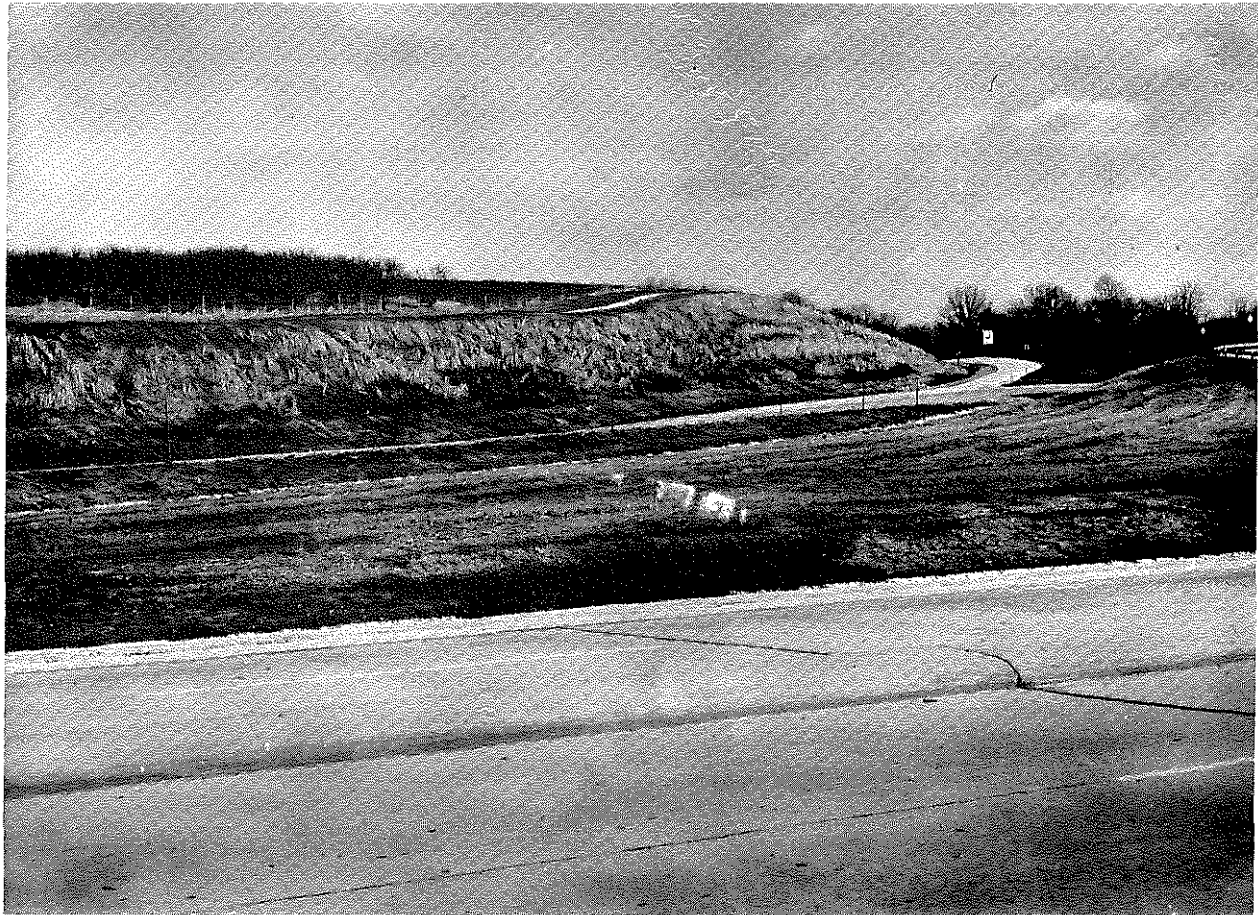
Figure 16. Photograph Showing the Cut Slope Illustrated in Figure 15 and the Benefits Derived in Preventing Surface Water from Flowing over the Edge of the Cut Slope. The paved ditch at the top of the cut was sufficient to carry the water horizontally rather than permitting it to flow over the edge of the slope.
